# GEOTECHNICAL REPORT

40481 / STROWAN FIELDS SUBDIVISION / TREVORS ROAD  
ASHBURTON / NEXT LEVEL DEVELOPMENTS LTD

**Title:** Geotechnical Report: Strowan Fields, Trevors Road, Ashburton

**Date:** 23 September 2021

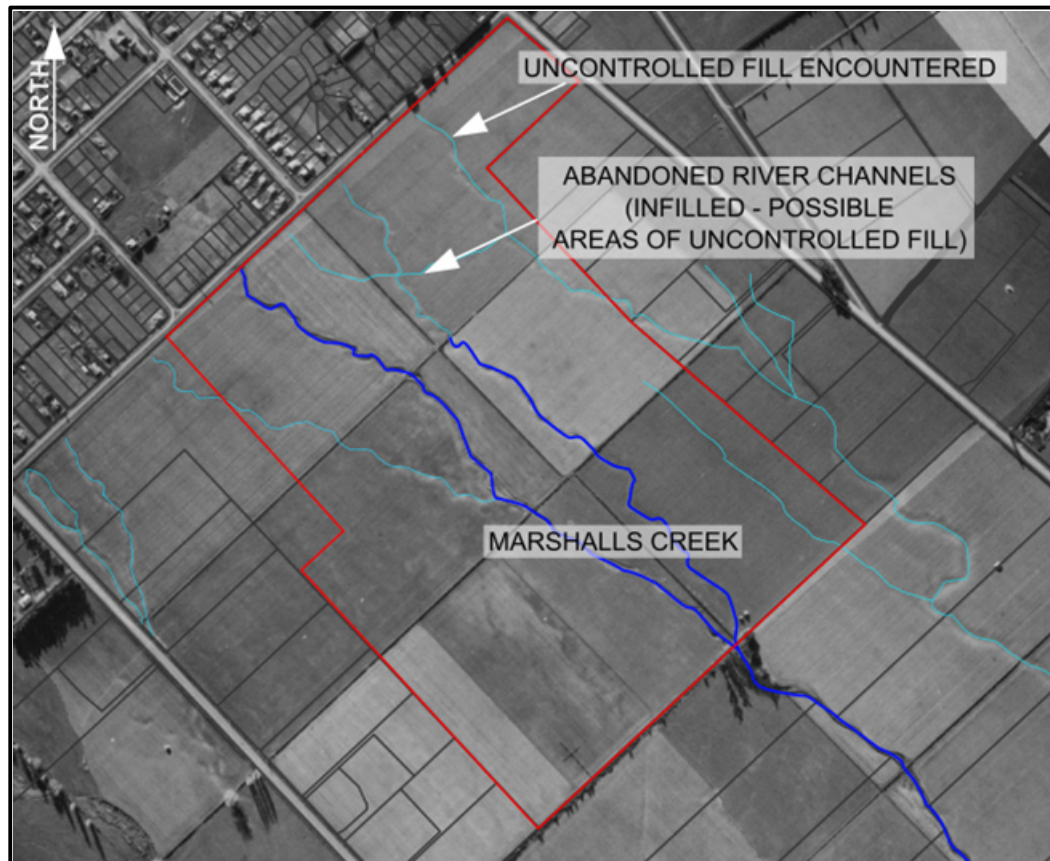
In the subsequent late 1950s imagery, the other abandoned river channels crossing the site are no longer visible, likely having been infilled. The north-western segment of the northern branch of Marshalls Creek channel has also been levelled. Residential buildings along Trevors Road are largely built by this time. Little change is noted on site between the 1980s and 2000s imagery with farming continuing on site. Some residential development has occurred on the lots surrounding the site, and the pump shed erected on site in c.2016.

**Figure 4: Imagery from 1940 showing the site (boundaries in red) used as farmland. Paleochannels observed from the imagery crossing the site are highlighted in light blue (buried channels) and are possible areas of uncontrolled fill. Dark blue line is Marshalls Creek.**

An earthworks allowance should be considered for over-excavating and appropriately backfilling any areas of deep fill or topsoil encountered on site. It is recommended that the channels are backfilled with engineered site won (silt) fill to achieve similar soil conditions (i.e., permeability) to that of the adjacent natural soils. Careful consideration must be given to the use of subsoil drains due to the likelihood of damage to these drains from future trenching and piping infrastructure.

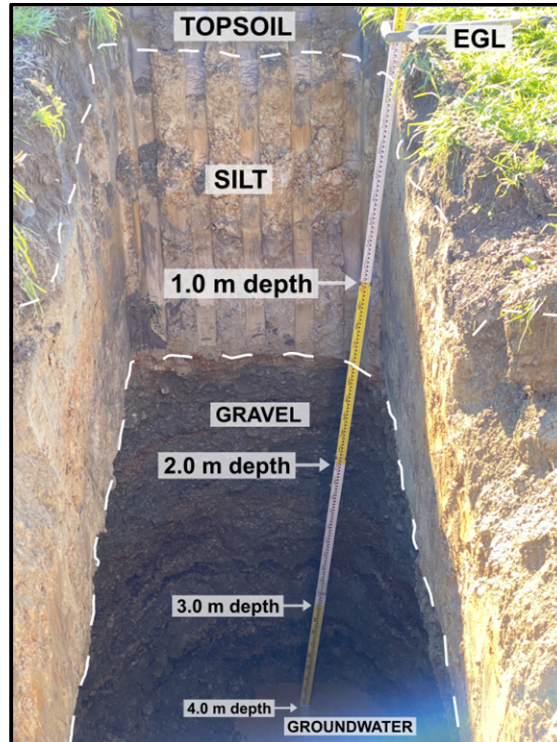
Figure 5: View of the typical subsoil profile (TP18) at Trevors Road to approximately 4.0 m below existing ground level (EGL). Photo date: 26 May 2021.

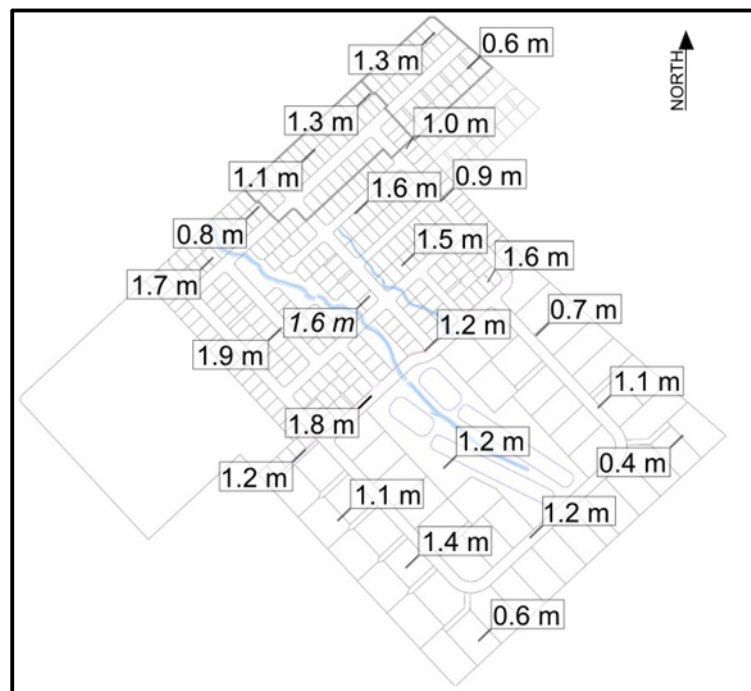
Figure 6: Annotated site concept plan showing summarised depths to gravel in meters below ground level.

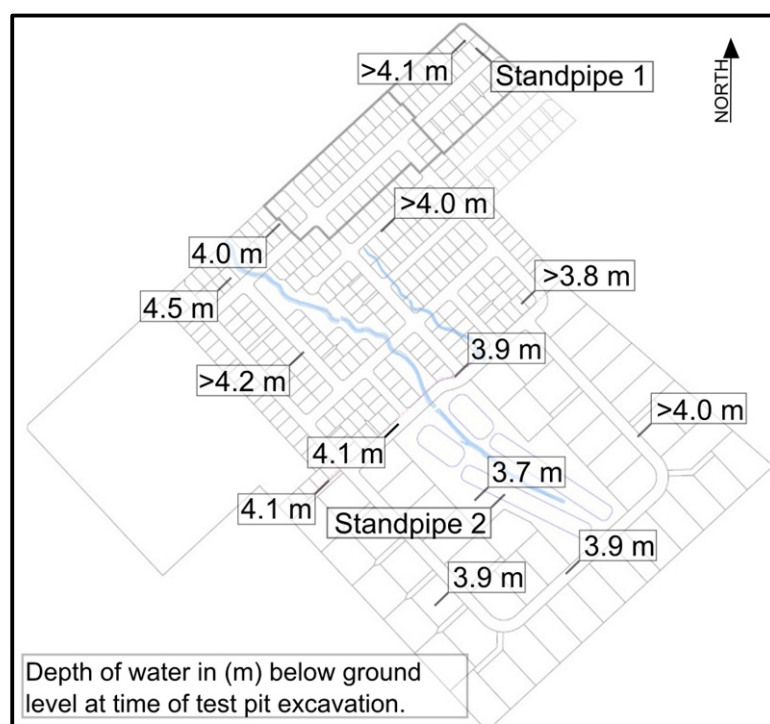
Variable depths to groundwater were encountered across the site. In the TPs towards the rear of the site (south-east) groundwater was encountered at 3.8 – 3.9 m below EGL (TP16, 18, 20), centrally on site at 4.1 m (TP21, 22), and a seepage was measured at the front of the site (north-west) adjacent to Trevors Road at 4.5 m below EGL. A summarised plan showing depth the groundwater across the site is shown in Figure 7. We note that the groundwater levels measured on site (May 2021) were typically 1.0 – 2.0 m deeper than those recorded by E2 Solutions in 2008<sup>12</sup>. This lower groundwater level may account for the iron-oxide staining observed in the gravel subsoils (e.g., Figure 6) above the groundwater table.

**Figure 7: Annotated site concept plan showing depth to groundwater in metres below EGL in May 2021.**
